# Collaborative Test Report

External fire exposure testing for energy storage systems (ESSs)

ESS observation while exposure of external fire sources

Sample : Li-ion ESS

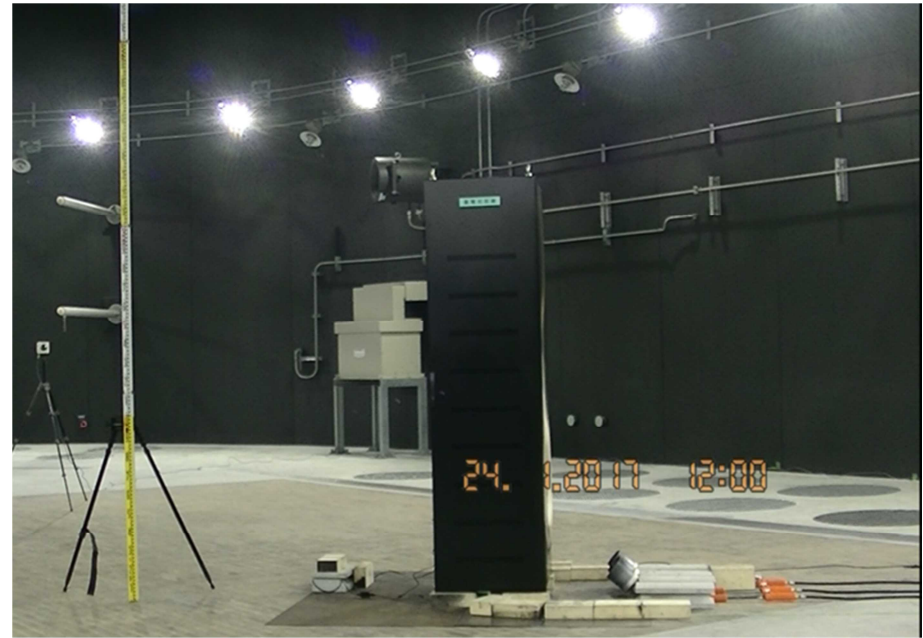
Fig. 8 Rack image after 90-minutes burning  
(Gas valves shut off)

The key events observed during the test were summarized in Table 4. Representative images about some events are provided in Figs. 5, 6, 7 and 8. Only in 1-minute burning, white smoke was escaped from gaps mainly of the front door for the upper half of the sample. However, just after ignition, no explosions or bursts of battery modules were observed. White smoke was not observed any more, about 30 minutes later, and abnormalities of battery modules were not also observed. Furthermore, additional exposure for about 30 minutes was conducted. However, abnormalities of battery modules were not observed for the test sample. After 90 minutes after fire ignition, valves of propane gas cylinders were shut off and the evaluation-test was terminated.

No.	Time (h:m:s)	Observed Event	Figure No.
1	–	Start measurement and video cameras recording Drive the flue-gas treatment system	–
2	10:30:15	Ignition 【Evaluation Start】	Fig. 5
3	10:30:37	Occurrence white smoke generation	Fig. 6
4	11:00:00	Stop of white smoke generation	Fig. 7
5	11:30:00	Extension of exposure time	–
6	12:00:20	Gas-valves shut off 【Test End】	Fig. 8

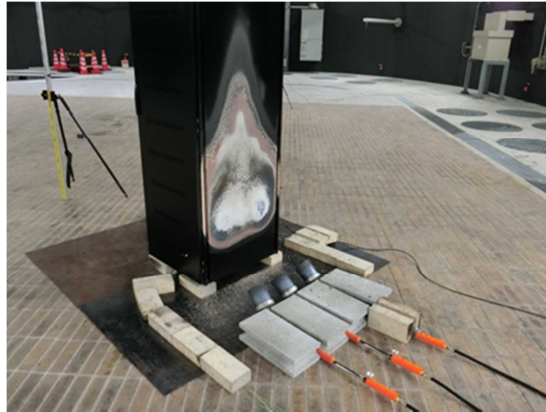
Fig. 12 Sample surface after fire exposure

Images of the sample after the fire exposure test are provided in Figs. 12, 13, 14 and 15.

The painting on both outside and inside walls of the fire-exposed face was removed and heat fading was observed on this face. However, abnormalities on other faces of battery rack were not observed. The front resin molded member on the fire exposure side battery module 9 to 14 burned out and deformed by heating, because the interior space of sample rack closest to burners was under a high temperature of over 400 °C as described in section 4.3. When battery module 10 was taken out from the rack, a little adhered soot was observed at the surface where battery module 10 was removed. No abnormalities such as explosion or burst were observed in all battery modules.

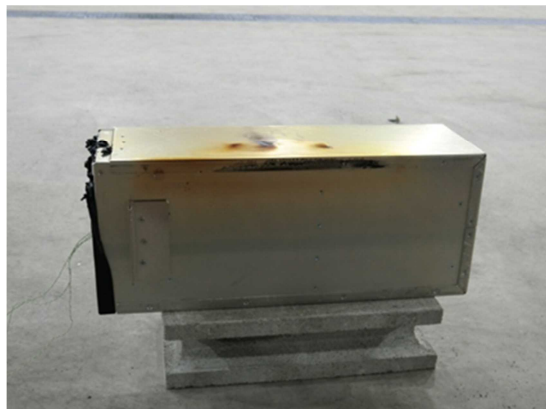
Fig. 14 battery module 10 taken out from the sample rack

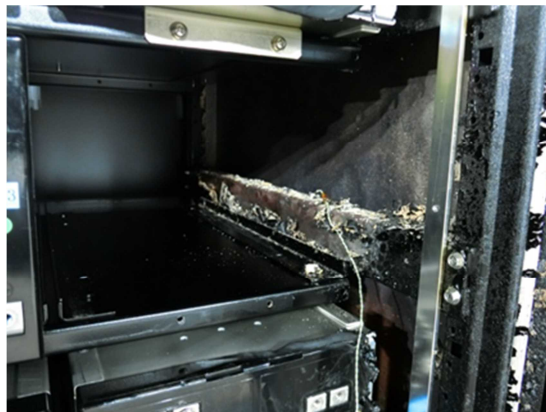
Fig. 15 Inside wall of the sample rack after exposure
